NATIONAL REGISTER OF HISTORIC PLACES  
REGISTRATION FORM

historic name: Cut Bank Ranger Station Historic District

Cut Bank Ranger Station Historic District, Glacier Co.,  
MT

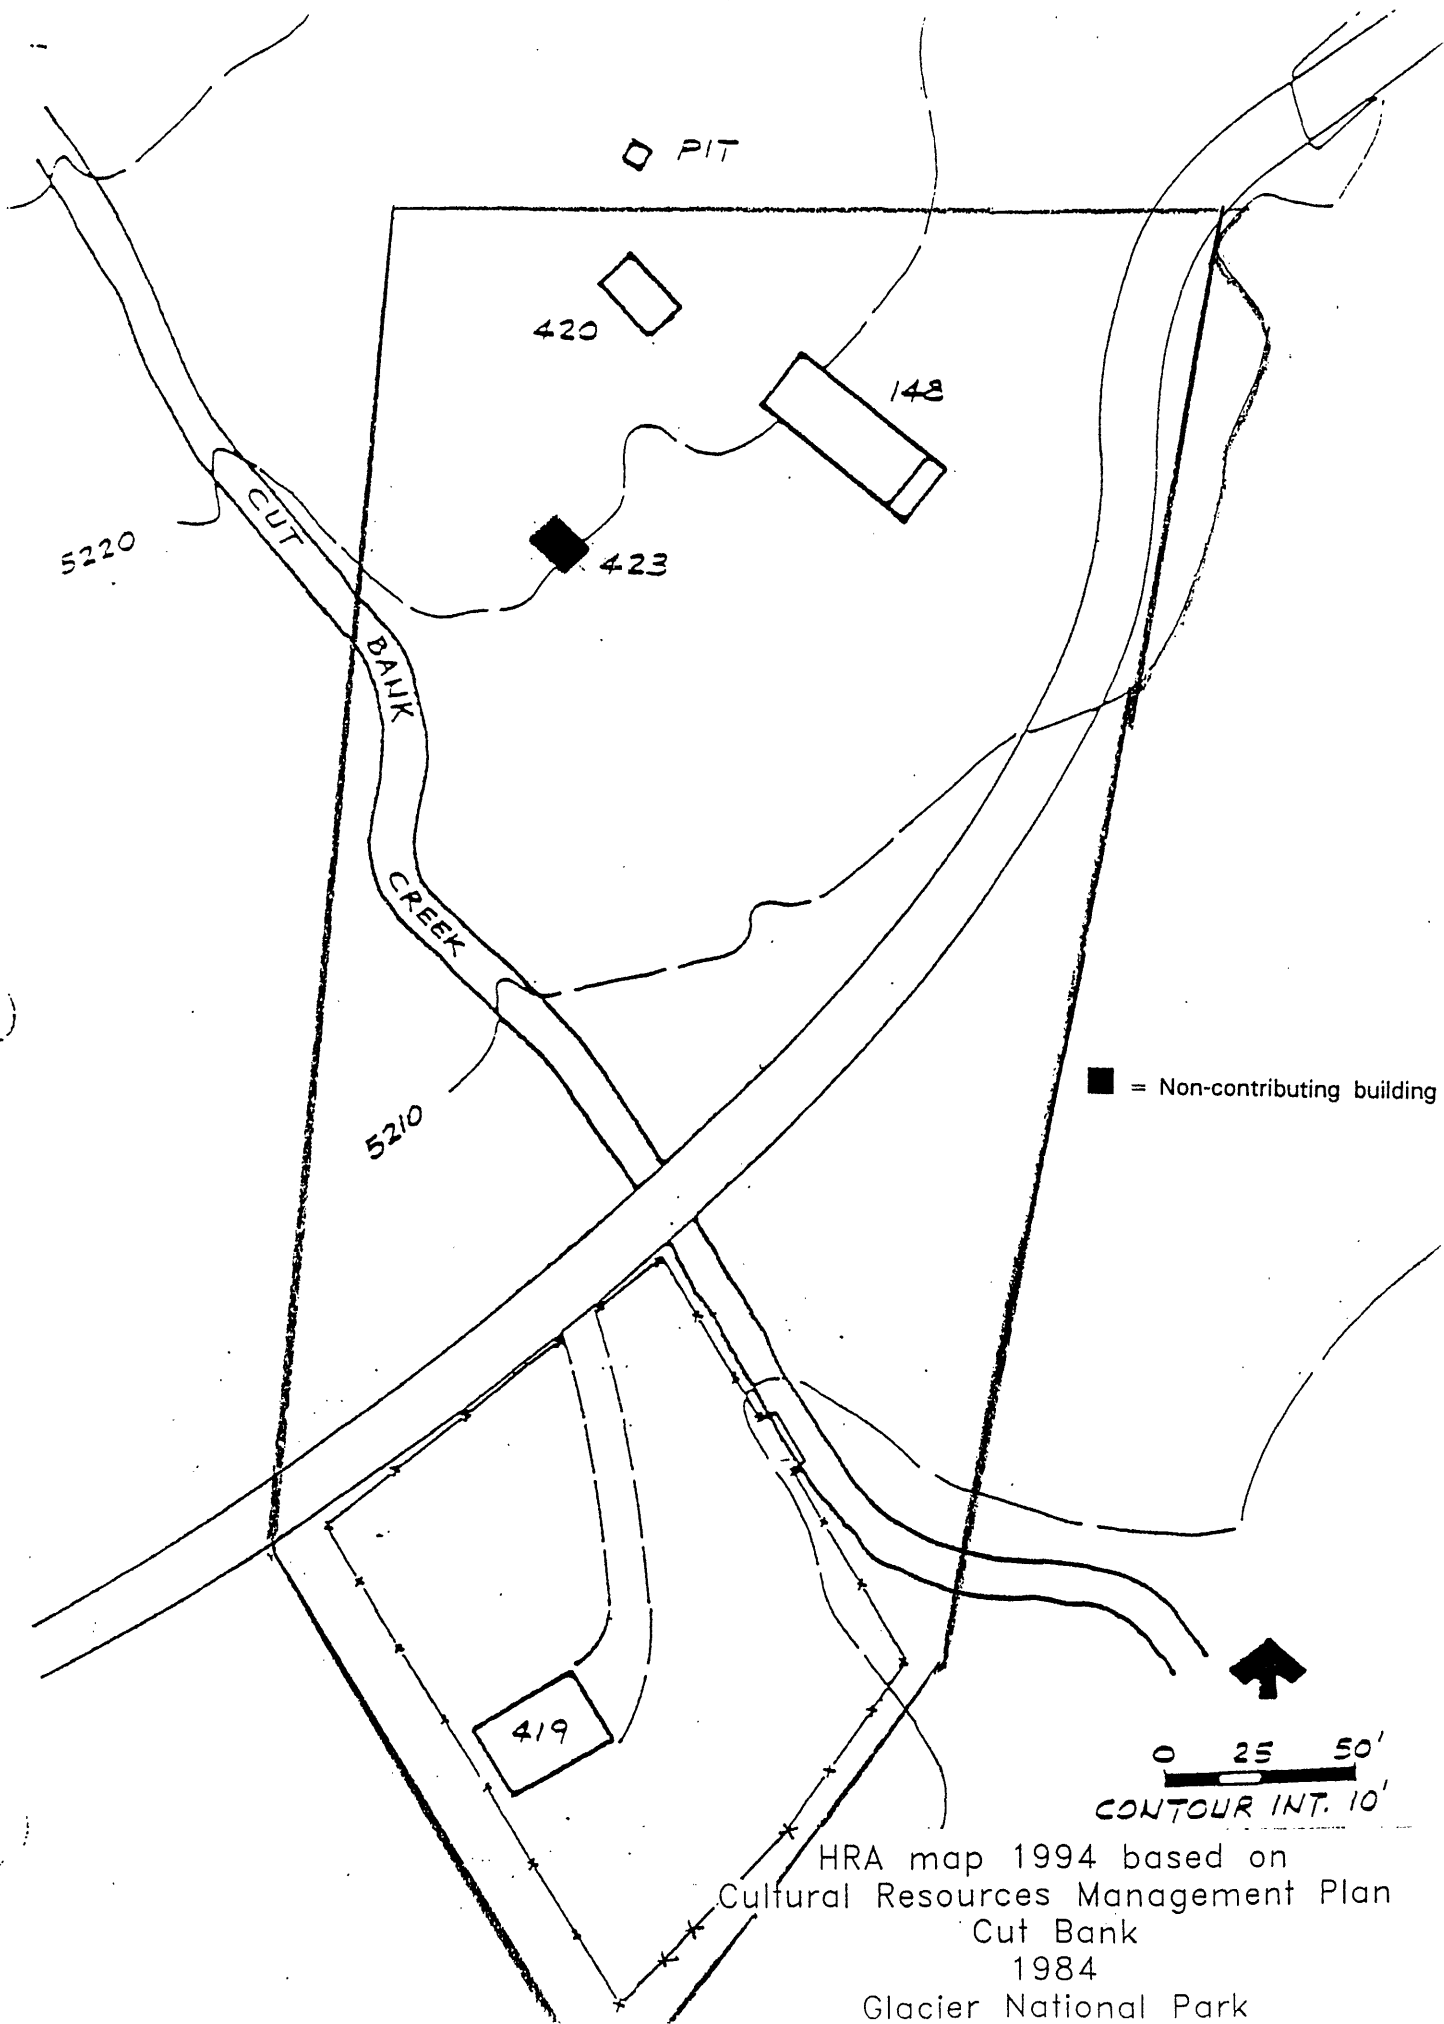
The boundaries incorporate all buildings and structures associated with the ranger station during the historic period. (See attached sketch map.)
